COMMUNITY PERCEPTION ON RESOURCE DEGRADATION: THE CASE OF TREES AND WATER SOURCES IN BAGA WATERSHED LUSHOTO DISTRICT.

Juma Wickama¹, Severina Mathias² and Veronica Kiluvia³

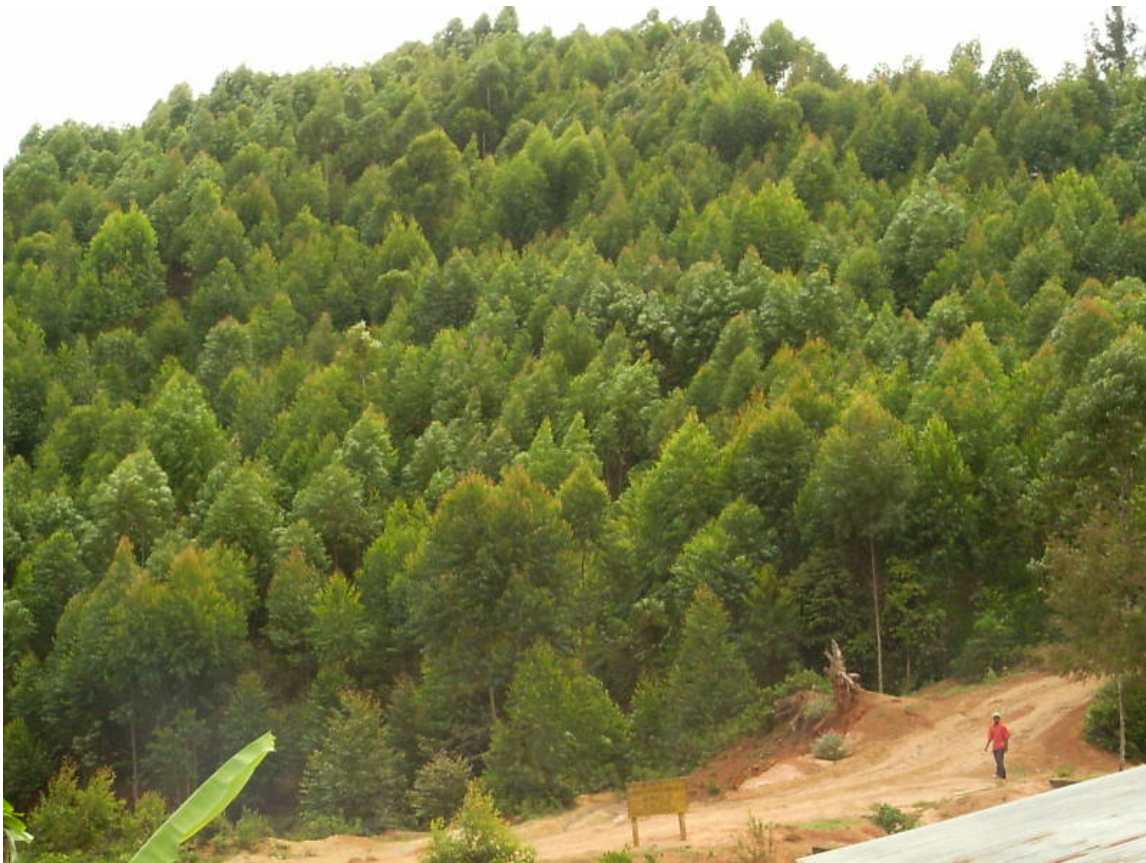
Plate 3. Eucalyptus woodlots are often blamed for drying of water sources in the Baga watershed

Similar effect was reported of fields bordering private eucalyptus wood lots in Kwekitui and Kwehangala. The contradiction around eucalyptus is two folds. First, nearly 40% of the women interviewed across the six villages actually preferred it against other trees in view of its ease in fire wood provision. Secondly 30% of the men interviewed while pointing out to its disastrous effects to the water sources still would prefer planting it in their fields because of its ease in the provision of building poles for both domestic and commercial use. However, 20% of the men interviewed were skeptical about its alleged destructive role. This group argues of knowing water sources still in use, which have eucalyptuses around them. In fact in Kwalei village one farmer (Mr. Thomas Nyundo) who has a two-acre wood lot of eucalyptus

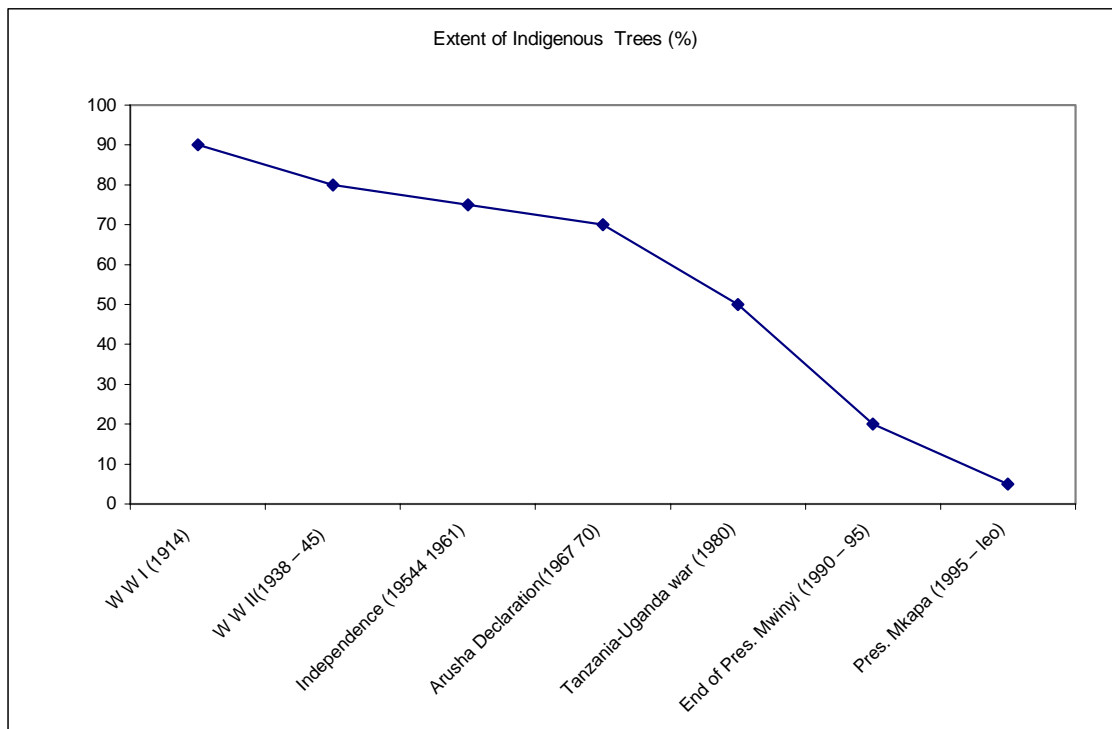
Figure 1. Trend in the decrease of indigenous trees in Baga Watershed in various periods

It will be noted that though there has generally been a steady decline in the presence of indigenous trees in the villages, the period “Arusha declaration” onward has a steeper decline. This could partly be attributed to the implementation of socialist policies in the form of villagization schemes. In these schemes, people were moved and resettled in newer areas where they established “Ujamaa (socialist) villages. To settle in these places required space for agricultural land and materials with which to build the villages. Many farmers attribute this period to significant clearing of natural forests after the initial clearance, which was done shortly after independence.

All farmers reported that there has been massive reduction of the indigenous trees across the six villages. They attribute the reduction to four major factors (a) indiscriminate felling of trees for expansion of agricultural land (b) population increase which adds pressure on the demand for land (c) increase in area allocated for human dwellings which has necessitated clearing of more land from the initial forests for that purpose (d) haphazard burning of fires in the forests. During the discussions with the groups we came up with this trend which shows a gradual decline in the forest cover with time.
